Service Bulletin

Engine Harness Rubbing – BC3-6560 only

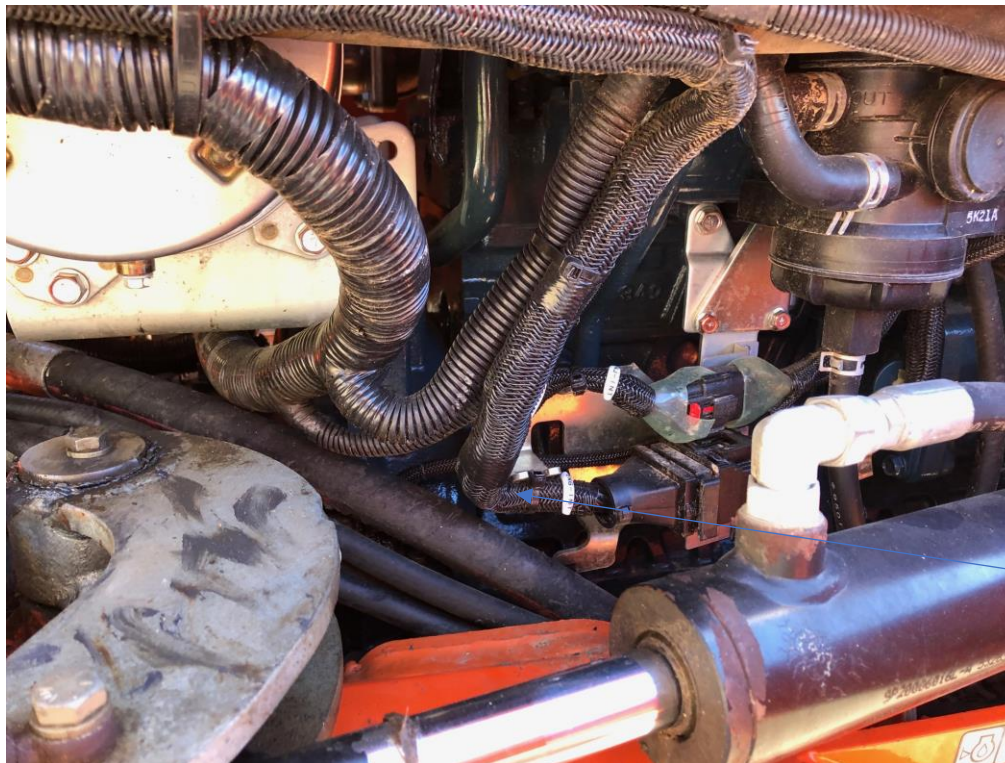
Please be aware that there may be an issue with the Kubota intermediate engine harness rubbing on the bracket mounted to the engine. Bright Coop has been notified of several issues in the field, and upon investigation, we have found that the hydraulic hoses may shift and cause this rubbing issue.

Inspect in this area on the back side of the harness

We are advising our customers, with a serial number less than 89, to inspect and correct this issue by either moving the harness to the top of the bracket, bending the bracket on the engine to ease the pressure from the hydraulic hoses, or both. The inspection area is on the back side of the engine, just to the right of the swing arm for the steer axle.
